EVALUATION OF CERAMICS FOR STATOR APPLICATIONS—GAS TURBINE ENGINES

FINAL REPORT - STATOR FABRICATION & EVALUATION

N.Arnon and W.Trela

MARCH 1983

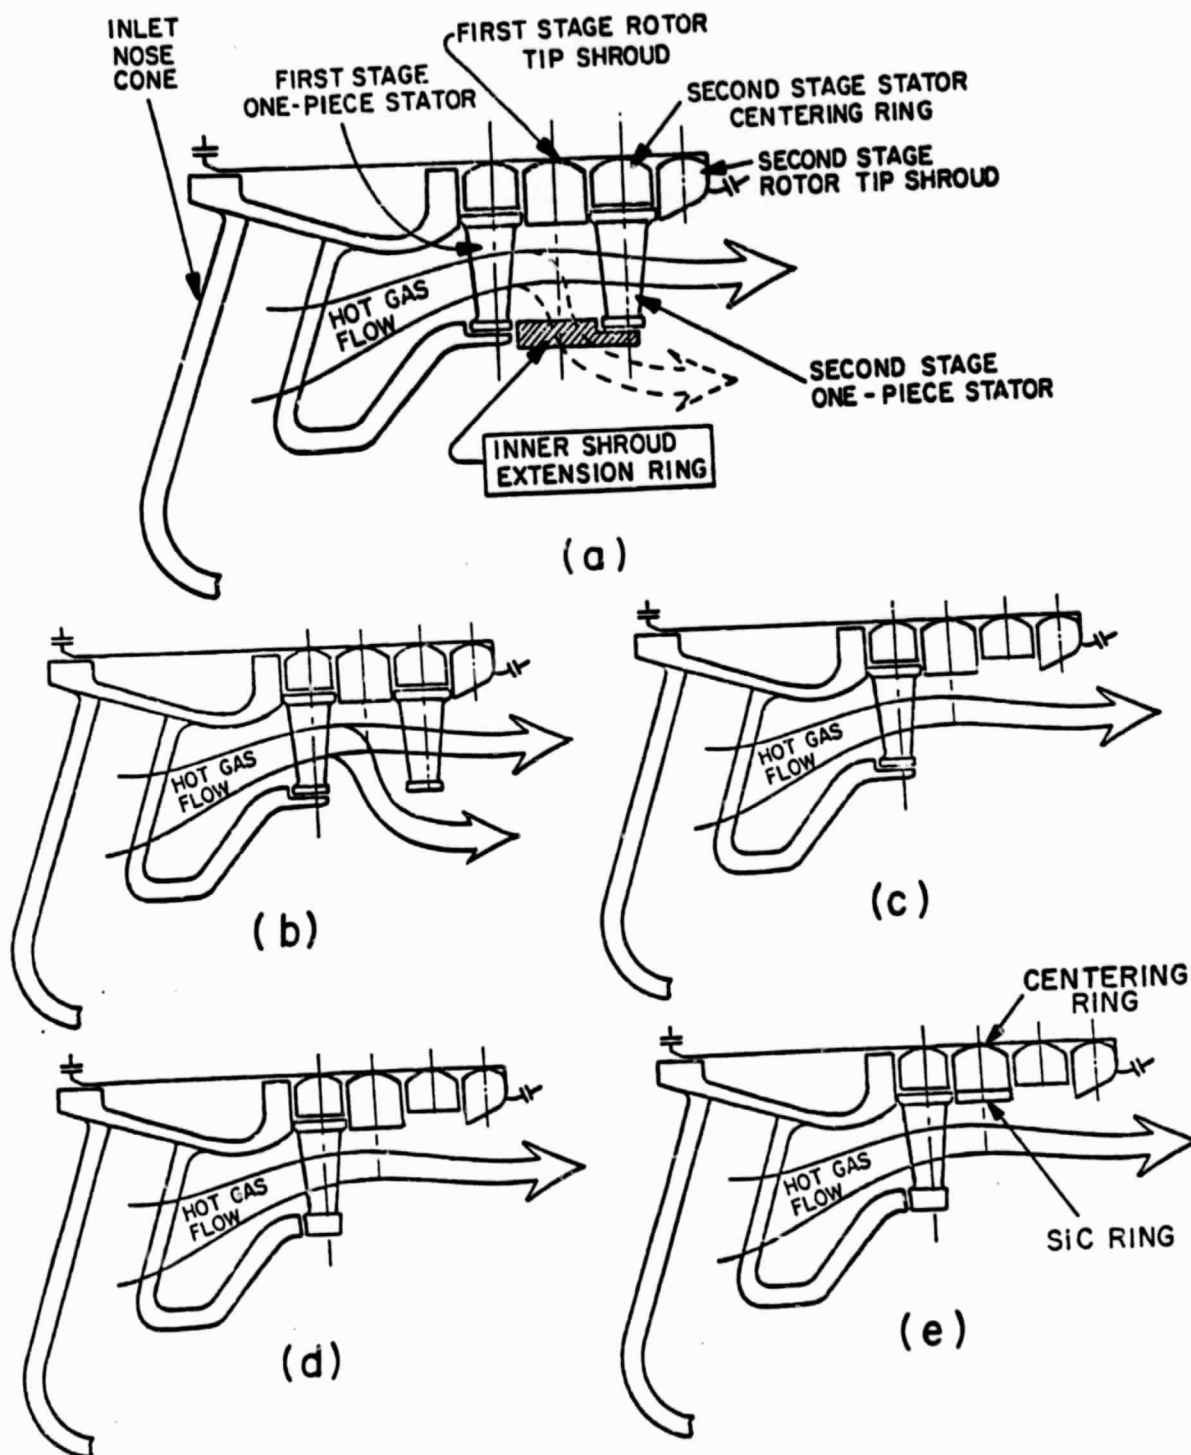
Figure 23 Hot Flowpath Test Configuration: (a) Complete Hot Flowpath with Inner Shroud Extension. (b) Extension Ring Removed. (c) Test Stator Only in First Stage Position. (d) Nose Cone Lip Removed. (e) SiC Backup Ring for SiC stator

The original configuration shown in Figure 23a included an inner shroud extension ring, a non-standard engine part. The ring was intended to prevent hot gas bypassing the second stage stator.

Although some durability testing was successfully completed, three second stage stator failures occurred during the first thirty hours of testing. The ring was removed (Figure 23b) and over 300 hours were accumulated without any major incident. Only Ford stators were run with these configurations.

Configuration "c" was adopted after a nose cone failure, damaging both stators. The first stage stator sustained damage from both the front and rear, complicating failure analysis. The second stage stator was not actually being subjected to engine conditions because of the hot gas swirl generated by the first stage. By eliminating one stator and adjusting the rig back pressure, conditions simulating engine operation would be maintained on the first stage stator without the jeopardy of secondary damage in the event of failure. Stators from all four participants were tested in the first stage with configuration "c".

The last two configurations were adopted to accommodate CBO stators. Configuration "d" had a modified nose cone (the pilot lip removed) to allow testing stators without machined inner shroud inside diameters. Configuration "e", with a SiC ring behind the stator outer shroud, was used to overcome interface problems which will be discussed later.

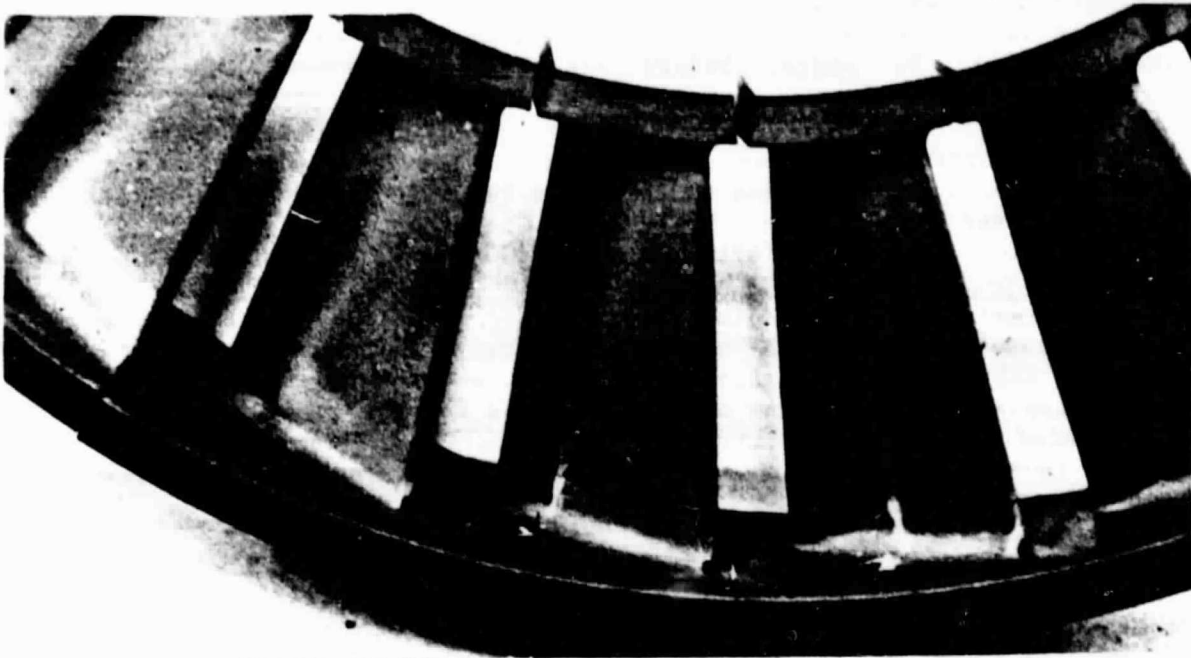
Figure 25

Evaluation of the Ford high-hour stator continued. Routine visual inspection after accumulating 523:31 test hours and 29,363 thermal cycles revealed a crack through the outer shroud and two vane cracks, as shown in Fig. 25. No cracks were observed during the previous inspection, after 28,856 cycles. The stator condition was documented, it was then re-installed in the rig for continued testing to meet the program objectives. The stator, despite the cracks, continued to function satisfactorily and no additional cracks occurred. In total the stator accumulated 535 hours of hot testing, which included 30,046 thermal cycles.

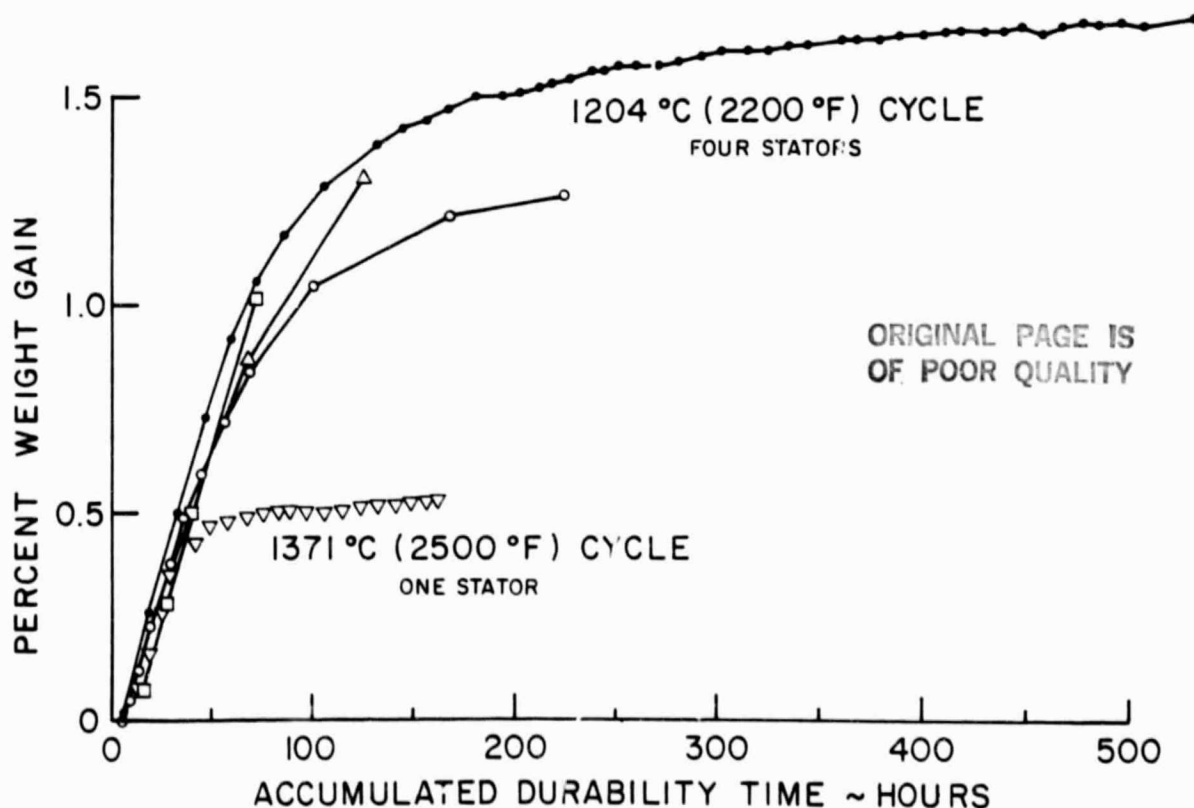
Figure 30 Weight Gain of Ford Si₃N₄ Stators

Weight gain curves for high-hour Ford stators are shown in Figure 30. The initial weight gain is the same under both duty cycles.

However, the stator run under the 1371°C (2500°F) cycle has stabilized after 75 hours while stators tested under the 1204°C (2200°F) cycle exhibited an increasing weight even after 500 hours of testing. Weight gain for the ACC Si₃N₄ stators showed a significantly different trend for the two different cycles. At the lower temperatures the weight gain was similar to Ford Si₃N₄ stators. However, during the short times run under the higher temperature cycle the initial weight gain was approximately four times as high as those for the lower temperature cycle as shown in Figure 31.

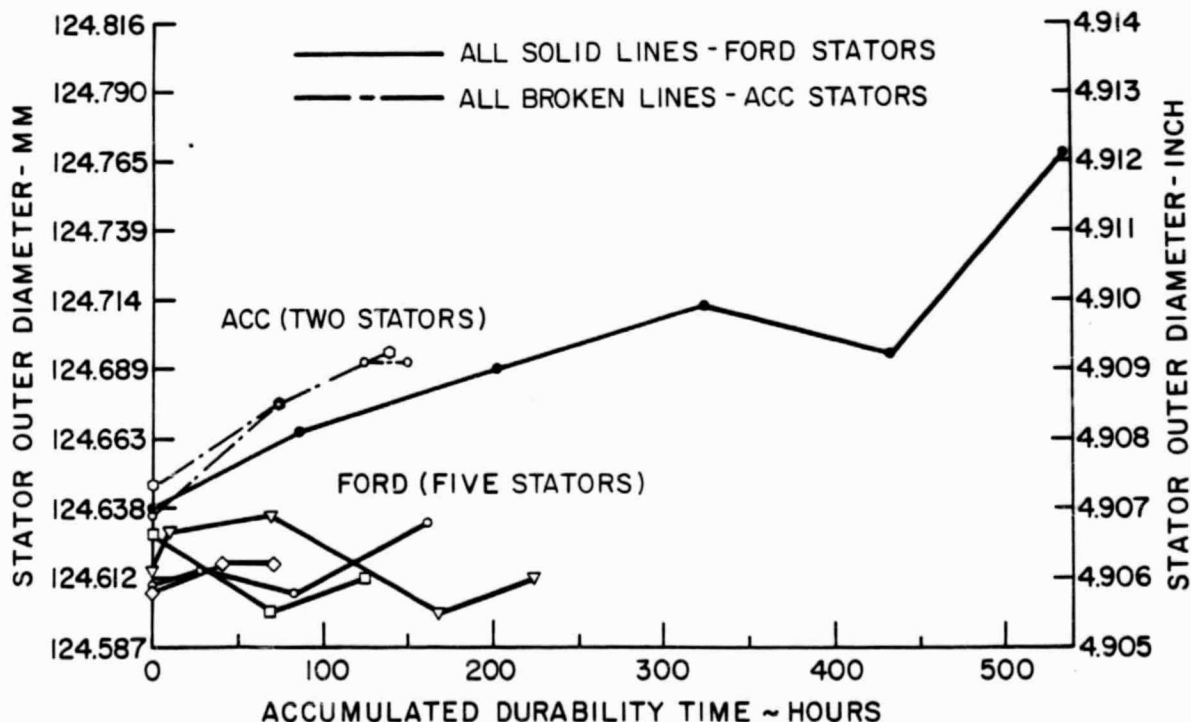
Figure 32 Stator Outer Shroud Dimensional Variation for ACC and Ford Si_3N_4 Stators

The Si_3N_4 stators showed no significant changes in outer shroud front face flatness. However measurable changes were obtained for the outer shroud nominal diameters (average of max. and min. diameters). Data obtained on all Si_3N_4 stators having successfully completed over 50 hours of durability is shown in Figure 32. At least 3 stators show clear trends of increase in diameter with durability time. Four other stators show no clear trend in dimensional variations and the data shown may merely reflect the inherent error in measurement.

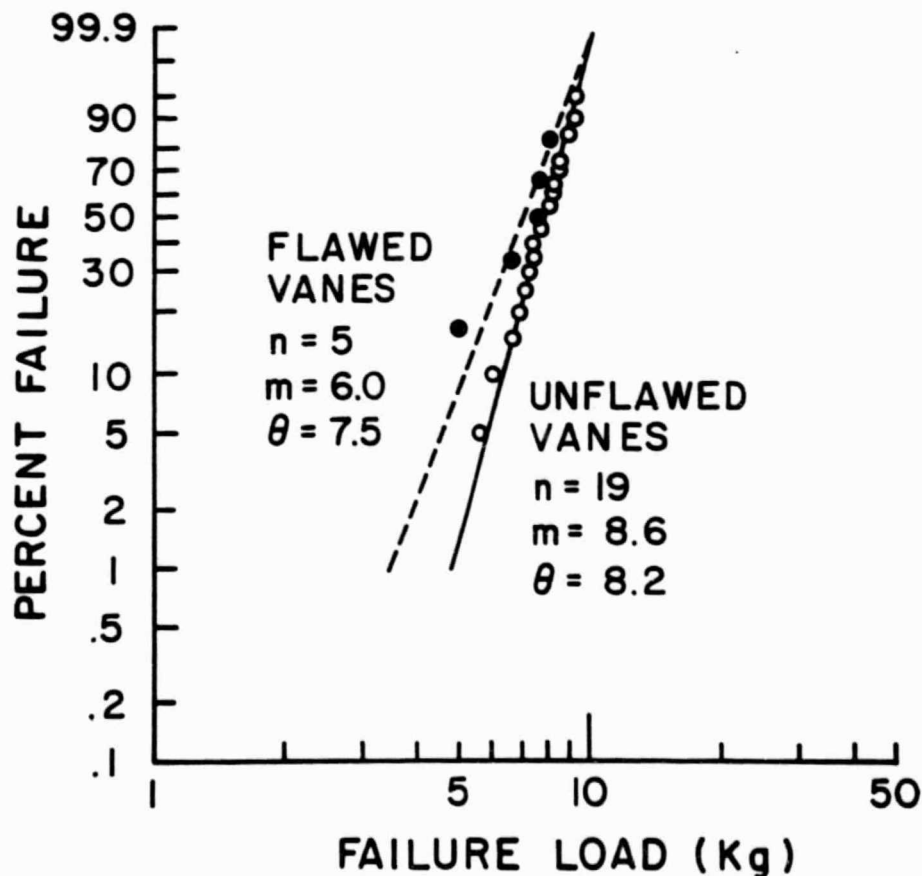
Figure 33 Failure Load Distribution of Flawed and Unflawed Vanes Loaded From Leading Edge Direction-Norton Slip Cast SiC Phase I Stator

a VBT load level, this stator was first zyglod and 5 vanes with flaw indications were loaded to failure. The stator was then light-off tested with no failures and no new zyglod indications. All remaining vanes were tested to failure. The resulting failure load distributions are shown in Figure 33. The curves indicated that although an 8.6 Kg. (19 lb.) proof test load would break 90% of flawed vanes, it would also break 70% of the vanes able to withstand the light-off test. Consequently the VBT was not used for qualifying Norton stators for durability.

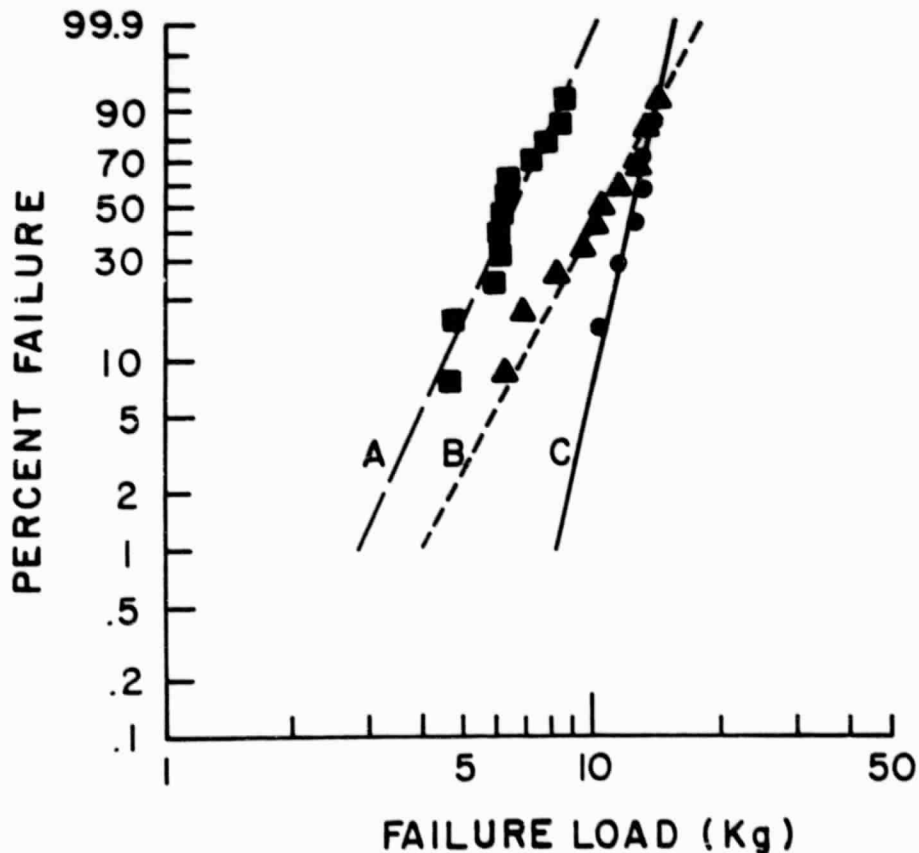
ACC stator S/N 01089, which had failed two vanes on the second durability test subsequently had all remaining vanes bend tested to failure. Fracture surfaces were visually examined at 30X for failure origin or flaw evidence. All fractures originated at the leading edge area. Seventeen of the 23 vanes had pre-nitriding, α Si_3N_4 planar defects near the leading edge. Twelve of the vane flaws had previously been recorded during the "as-received" visual inspection.

Weibull plots for three groupings of the failure load data are shown in Figure 34. The first group (Curve A) includes only the data from vanes with surface flaws detected in the "as-received" condition.

These vanes exhibited a low characteristic strength of 7.1 Kg (15.7 Lbs.) and considerable scatter ($m=5.0$) but could readily be screened out by visual NDE. The second group (Curve B) includes the 11 vanes with no visible surface cracks in the failure region. A significantly higher strength is achieved but the scatter remains due to the presence of sub-surface flaws such as those shown in Figure 35. Screening out of such flawed vanes requires more elaborate NDE beyond visual inspection or use of qualification tests such as the vane bend test. In the case of this stator, 84% (16/19) of the flawed vanes would have failed at the 8.6 Kg (19 lb) load level.

The third grouping in Figure 34 (Curve C) includes only those vanes with no observed flaws at the fractured surface. The characteristic strength was improved still further to 13.1 Kg (29.0 lbs.) and a significant reduction in the scatter achieved ($m=9.9$).

Weibull Curves for Vane Bend Test Results From ACC Stator S/N 01089. (A) Vanes With Flaws Observed During "as-received" Visual Inspection. (B) Vanes Without Flaws Observed During "as-received" Visual Inspection. (C) Six Vanes From (B) Without Flaws on Fracture Surface

The vane bend testing conducted has served to reinforce the usefulness of such tests as a quality check on ceramic components. For example, the data in Figure 34, for an ACC stator, shows that even if that stator contained none of the flawed vanes of curve A (observable by visual NDE) the stator would have failed 3 vanes at an 8.6 Kg (19 lb.) qualification level. Such a situation occurred in Stator S/N 10137 which was used in generating the data for Figure 38a. The stator was judged acceptable by NDE, but failed to pass the VBT. The inferior quality of that stator is further evidenced by the fact that all four of the lowest data points plotted in Figure 38a are from that stator.

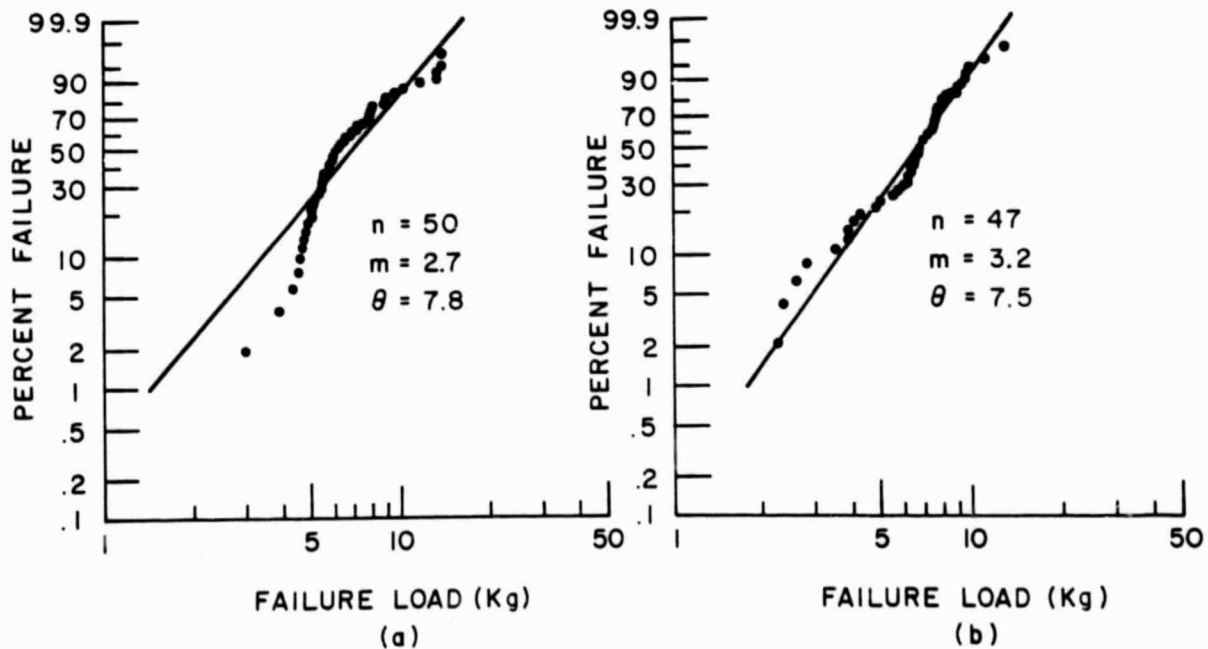
Figures 36 through 39 present vane bend strength data generated for evaluating the effect of durability testing. Four stators from each participant were vane bend tested to failure; two with no (or very little) test time and two with the highest durability times. Vanes which had been cracked or damaged during durability testing were not included. Based on the computer generated population estimate line, no significant reduction in Weibull slopes or characteristic strengths occurred during durability testing for any of the materials. The MLE straight line fit to the data in these figures will be discussed later.

Figure 36 Vane Bend Strengths of ACC Si_3N_4 Stators:
(a) Without Durability Cycle Testing - S/N 0227922
and 0212926. (b) After Testing - S/N 0125911
(149 hrs) and S/N 0206957 (135 hrs)

Two further observations regarding Figures 36 through 39 should be considered. First, the two-parameter MLE fit to the data points is obviously not a good fit. This suggests that mixed failure modes or distributions are present in complex shaped parts such as the stator. Second, the slopes of the MLE lines are lower than usually observed for material characterization samples. For example, in the material property characterization effort in this program, test bar strength data for the Ford and Norton materials had slopes of 10.6 and 5.8 respectively. The slopes of the VBT data on these same two materials were in the ranges of 8.2 to 8.9 and 3.1 to 5.1, respectively.

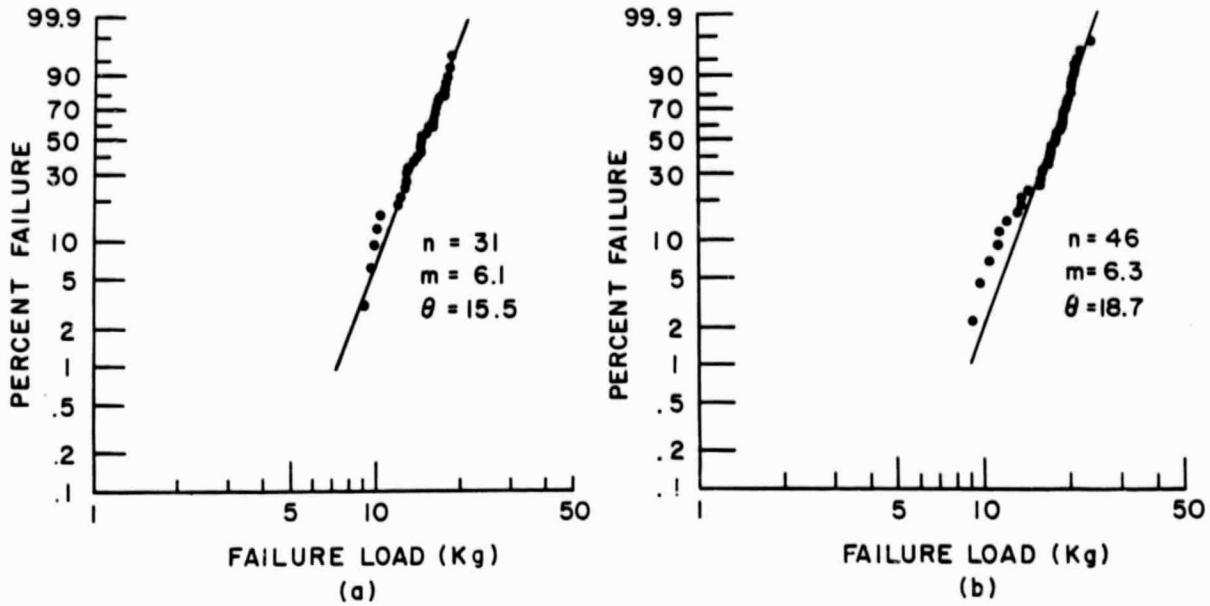
Figure 37 Vane Bend Strengths of CBO SiC Stators: (a) Without Durability Cycle Testing - S/N 56 and 59. (b) After Testing - S/N 68 (247 hrs) and S/N 71 (299 hrs)

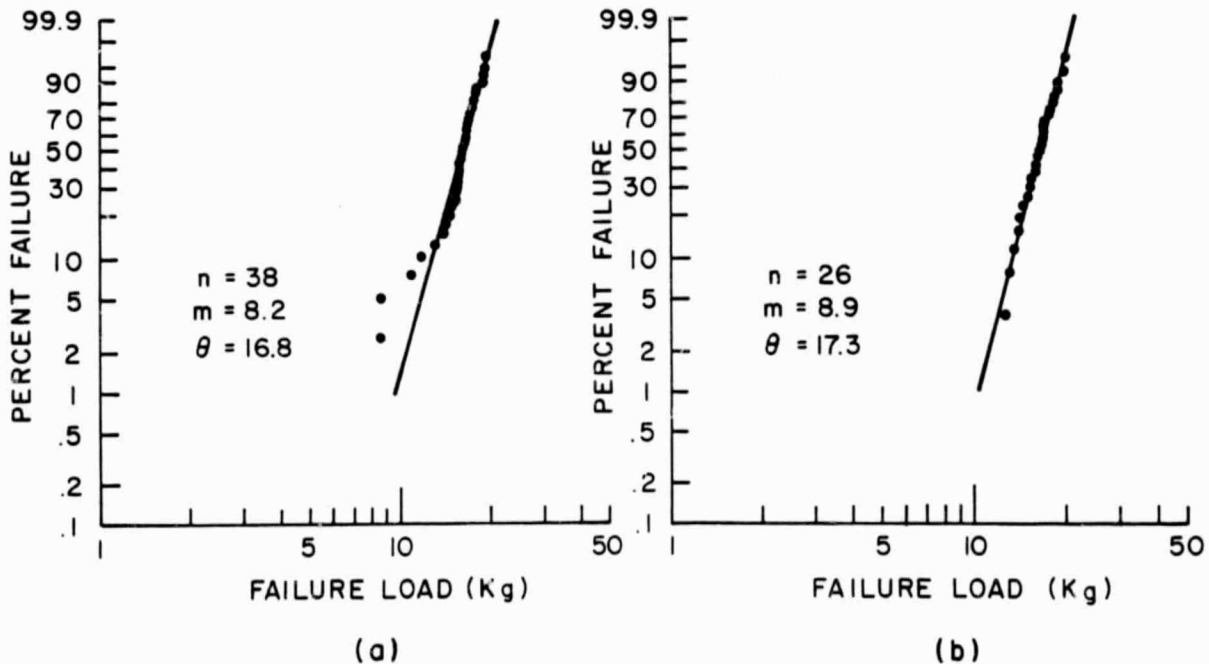
Figure 38 Vane Bend Strengths of Ford Si₃N₄ Stators: (a) With 0-10 hrs Testing - S/N 10137 and 10082. (b) After Testing - S/N 10146 (293 hrs) and 10068 (535 hrs)

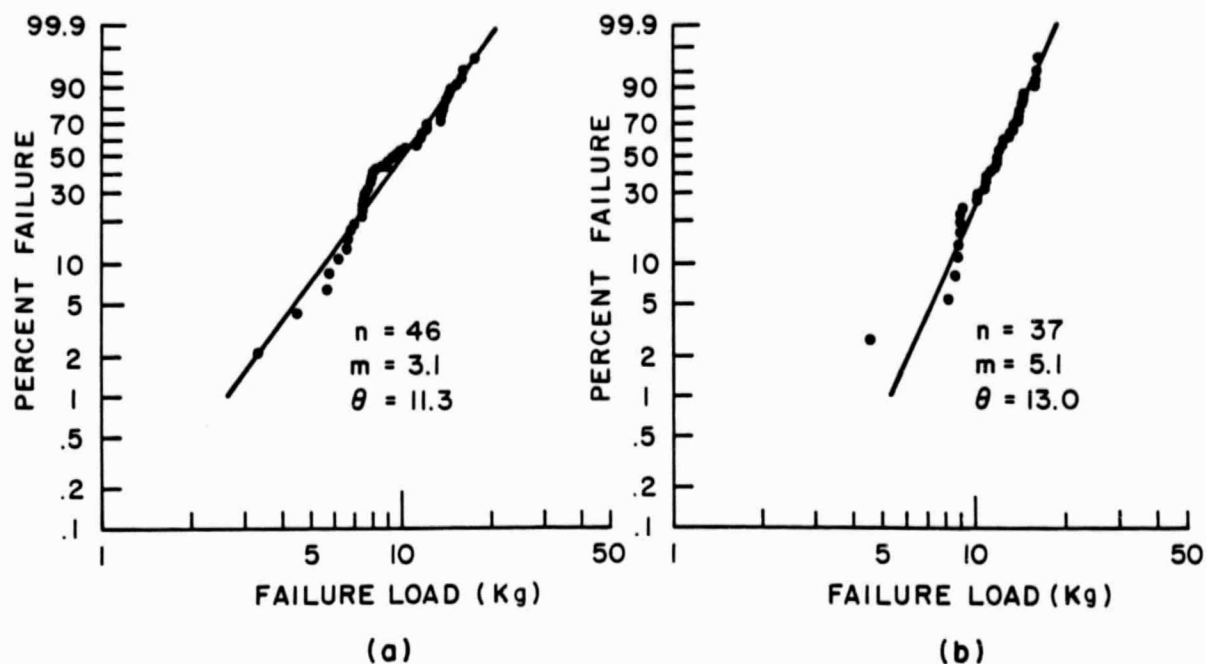
Figure 39 Vane Bend Strengths of Norton SiC Stators:
(a) Without Durability Cycle Testing - S/N H and O.
(b) After Testing - S/N J (82 hrs) and P (82 hrs)
